# Strengthening of a Reinforced Concrete Bridge with Polyurethane-cement Composite (PUC)

Zhang Kexin\* and Sun Quansheng

Faculty of Civil Engineering, Northeast Forestry University, Harbin, 150040, China

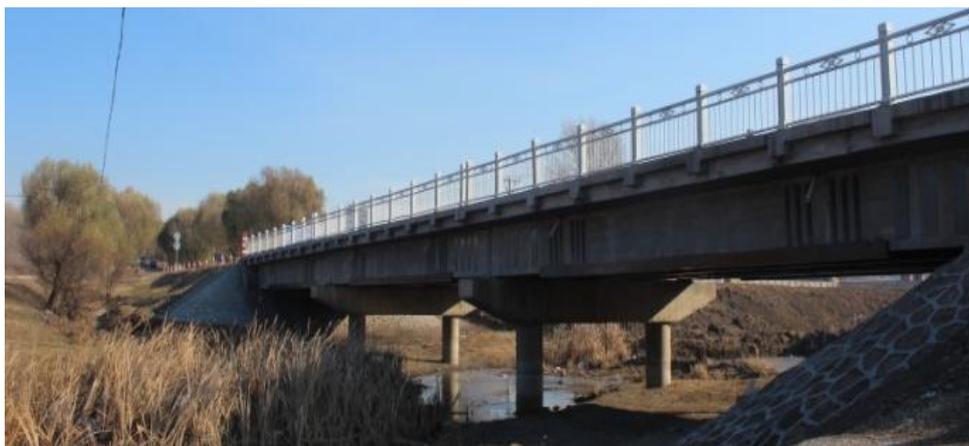
Fig. (1) shows a lateral view of Yun Liang Bridge in Harbin, China. The bridge was built in 1989. It carries an average daily traffic of 800 vehicles. The superstructure consists of three simply supported 20.0m long spans. Central supports consist of reinforced concrete bents, each supported by two circular columns. The total width is 11.5m, and the width of the driveway is 9.0m. The bridge has two lanes and carries one lane of traffic in each direction. The superstructure cross-section consists of five precast RC beams, supporting a 2.2m wide deck, as shown in Fig. (2).

Fig. (1). Lateral view of Yun Liang bridge.

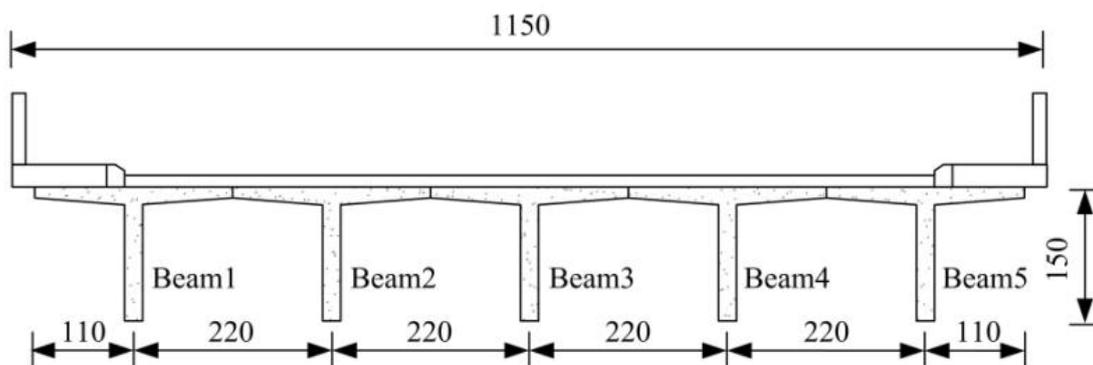
Fig. (2). Cross-section of the bridge.

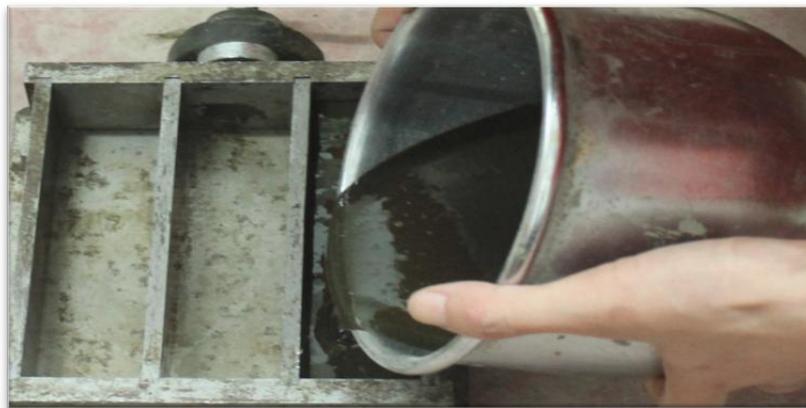
**Fig. (3).** PUC material after mixing.

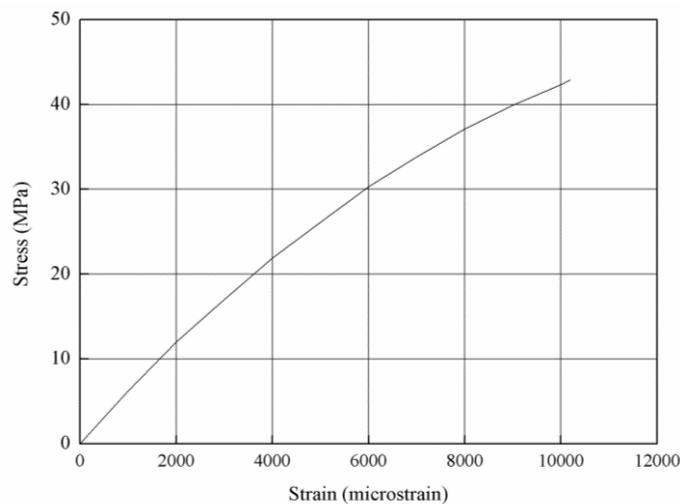
In achieving excellent mechanical properties, PUC with a density no than less 1,400kg/m<sup>3</sup>, was used to strengthen the beam. In the flexural loading process, the same density of PUC showed the same elastic stress-strain curve until the material was damaged. PUC after mixing is shown in Fig. (3). The density of PUC mixed in the construction site was 1,458 kg/m<sup>3</sup>. The blending stress-strain cure of the PUC in the construction site is shown in Fig. (4). Ultimate flexural strength ( $f_{pu}$ ) was about 42.3MPa. Design flexural strength ( $f_{pd}$ ) was designed to be 3/4 of the ultimate flexural strength, and the corresponding strain was 0.006 under the design flexural strength. The minimum modulus of elasticity ( $E_{pd}$ ) was 5MPa. Table 1 shows the properties of PUC.

**Fig. (4).** Flexural stress-strain curve of the PUC.

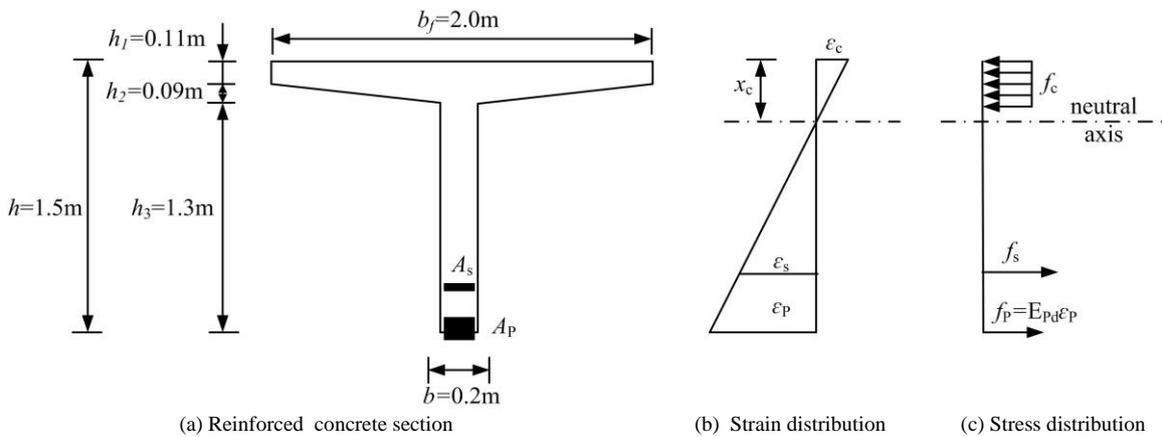
The results of the survey and inspection showed that the bridge’s service ability was insufficient in terms of cracks, erosion and vibration. Moreover, the owner of the bridge asked to complete the strengthening work with minimum interference to traffic. Therefore, the strengthening of an RC T-beam bridge with PUC was designed. The beam blending bearing capacity was analysed through the assumption that the plane section remained to be planar until failure. Blending bearing capacity was evaluated based on force equilibrium and strain compatibility until failure, as shown in Fig. (5).

The failure of the RC T-beam strengthened with PUC was beam bending failure because of the strong bonding performance between PUC material and concrete. The flexural capacity of the PUC -reinforced member depended on the concrete crushing or the design flexural strength of PUC material. Two kinds of failure modes exist for PUC -strengthened RC beams according to Fig. (5) and plane assumption.

Fig. (5). Internal strain and stress distribution for a T-shape section.

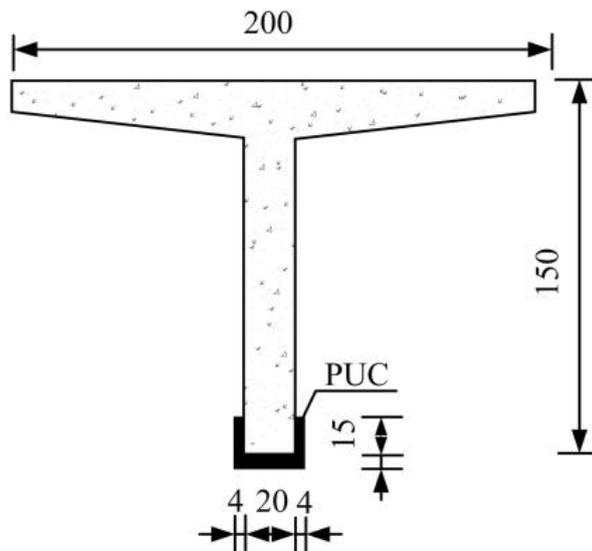
The above mentioned analysis shows that the bearing capacity of the strengthened beam is controlled by the design flexural strength of PUC material. The flexural strength increased to 1036.8 through the pouring of PUC material. The section of the T-beam strengthened by PUC is shown in Fig. (6).

Fig. (6). PUC material strengthening T-shape beam section.

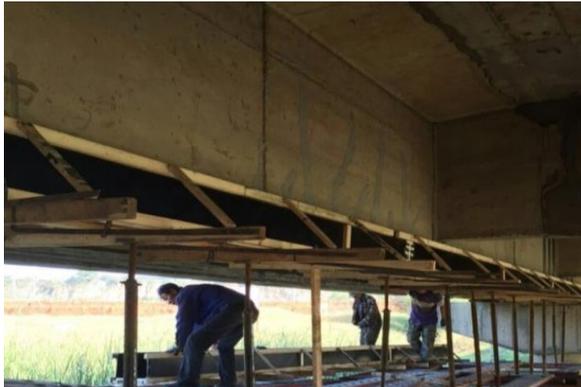
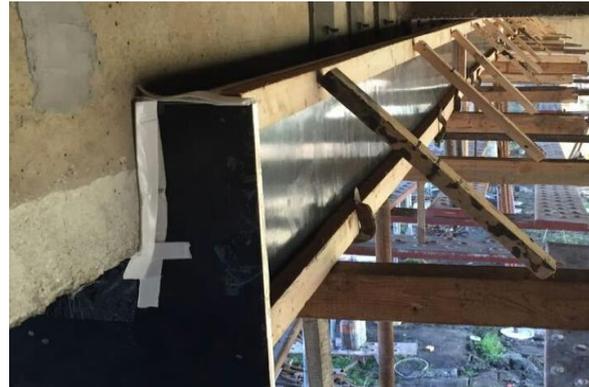
(a) Lateral view

(b) Enlarged view

**Fig. (7).** Installing template on the beam.

In achieving a better bonding effect, sufficient time must be ensured to dry the concrete surface naturally. The construction templates were made depending on the design of the dimensions of the PUC material. The template was installed in the specified location, as shown in Fig. (7). The mixing ratio of the PUC components (polyol: polyisocyanate: cement) was 1:1:2.5 by weight. The mixed PUC material was poured into the templates. The templates were removed after two hours, as shown in Fig. (8).

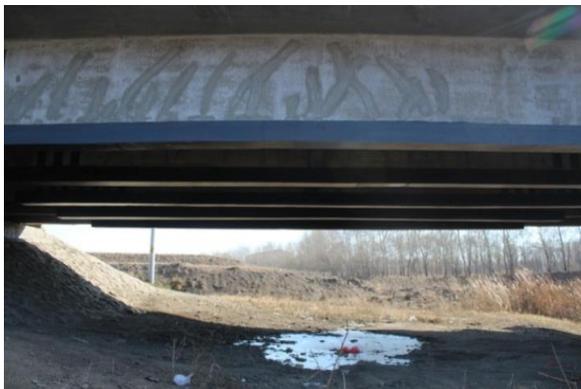
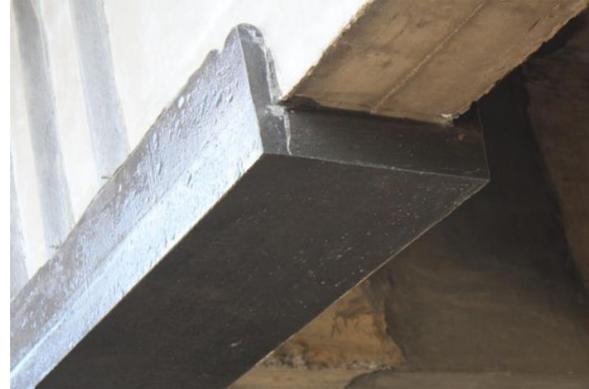
(a) Lateral view

(b) Enlarged view

**Fig. (8).** Strengthening of RC beams with PUC.

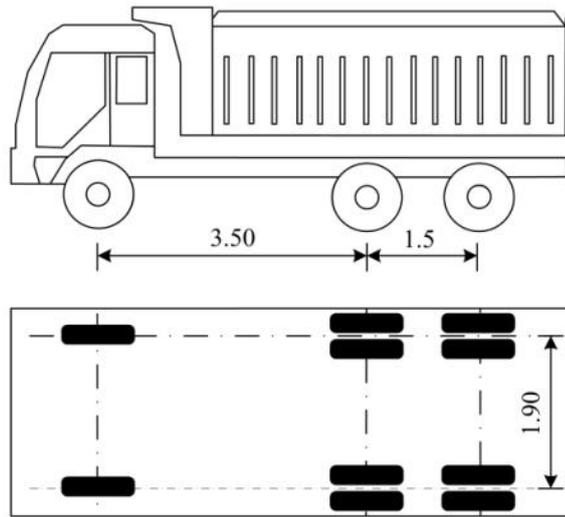
Before strengthening and two months after strengthening, load tests were performed to obtain the service ability of the bridge. These tests are repeated once a year and they will continue over a period of three years. Three-axle trucks are used as live load. The details of the trucks are shown in Fig. (9). The gross rail loads before and after strengthening are listed in Table 2. The bridge test was performed under two conditions. The two trucks were used at different locations for each condition and were assigned with unique letters A and B.

Fig. (9). Load-test truck configuration.

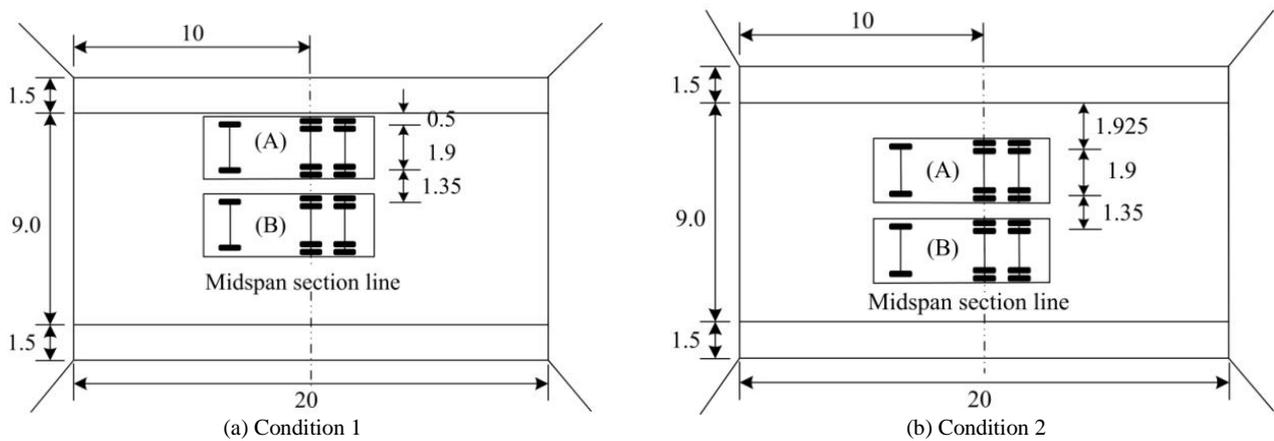
The testing of each condition was sequenced as follows: Truck A, Truck A + B, Truck A. The two conditions are shown in Fig. (10). For condition1, the two trucks deviated from the centre line of the bridge, and the distance from the outside wheels to the pavement edge was 0.5m. For condition2, the two trucks were symmetrical with the centre of the bridge, and the distance from the outside wheels to the pavement edge was 1.925m.

Fig. (10). Distribution of load-test trucks on the bridge deck at different paths. (a) Condition 1. (b) Condition 2.

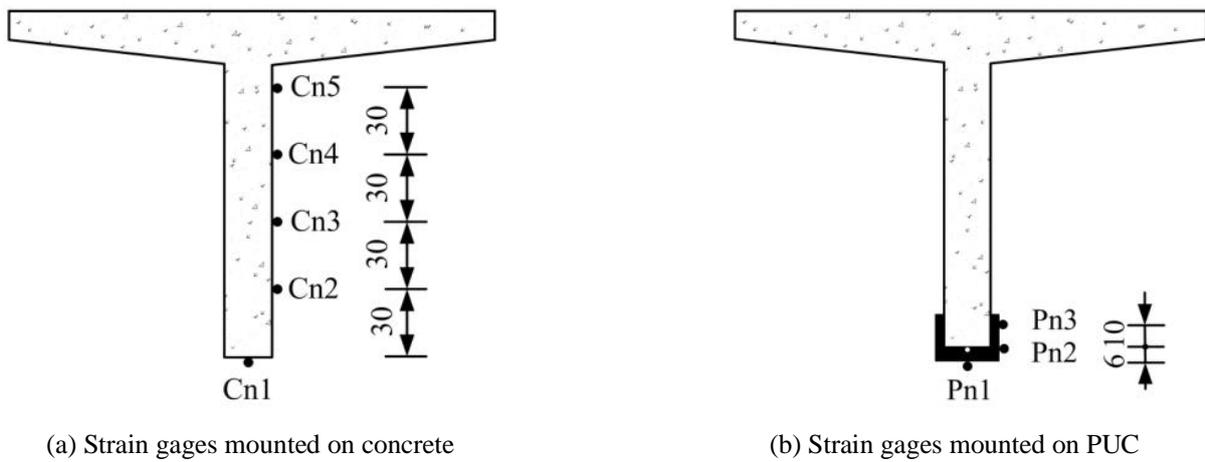
Strain gages were placed on the concrete surface in the cross, with the detailed locations shown in Fig. (11a). The letter n represents the beam number, and the letter C represents the concrete strain gages. Resistance strain gauges (Cn1) were installed on the bottom of the beam before strengthening, as the bottom of the beams was covered with PUC after strengthening. The strain gages of the PUC surface are shown in Fig. (11b). The letter P represents the PUC strain gages. The gage Pn2 and the gage Cn1 were installed at the same horizontal position. The strains were collected at a rate of two readings per second.

**Fig. (11).** Locations of strain gages mounted on the beams (n is the beam number). **(a)** Strain gages mounted on concrete. **(b)** Strain gages mounted on PUC.

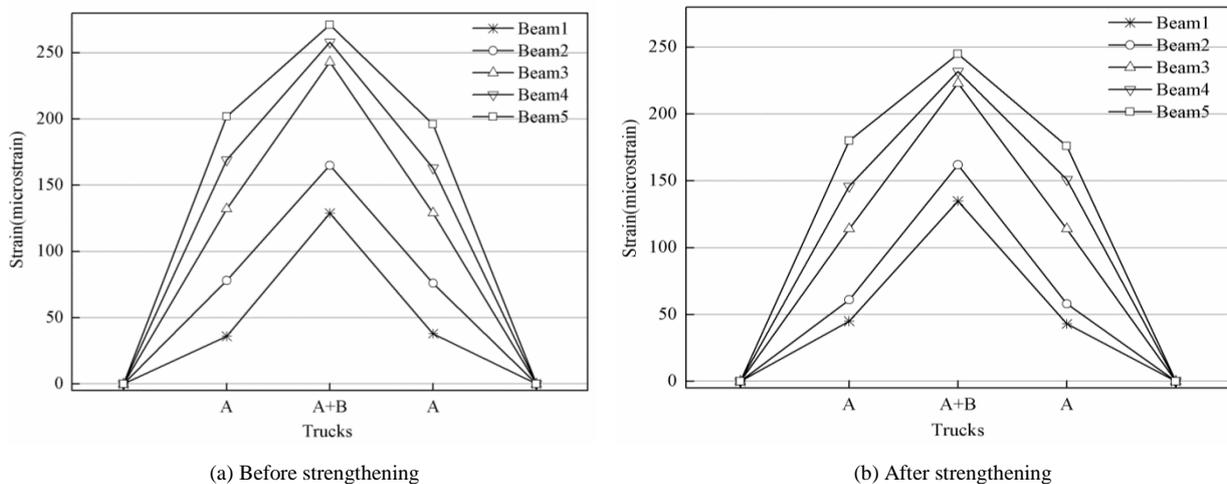
Fig. (12) shows the concrete strain on the bottom concrete surface under live load in condition 1 before and after strengthening. The strain was the largest in the edge beam. The maximum strain of beam 5 was 271 microstrains for the two trucks (Trucks A + B) before strengthening because of the damage and the weak interaction between the beams. After strengthening, the maximum strain of beam 5 was 245 microstrains for the two trucks (Trucks A + B). The maximum strains of beam 4 were 258 microstrains and 232 microstrains before and after strengthening, respectively. The strain was reduced to about 26 microstrains. The maximum strains of beam 3 were 243 microstrains and 223 microstrains before and after strengthening, respectively. Therefore, the concrete strain can be reduced after the PUC material is poured.

**Fig. (12).** Recorded concrete strains in condition 1. **(a)** Before strengthening. **(b)** After strengthening.

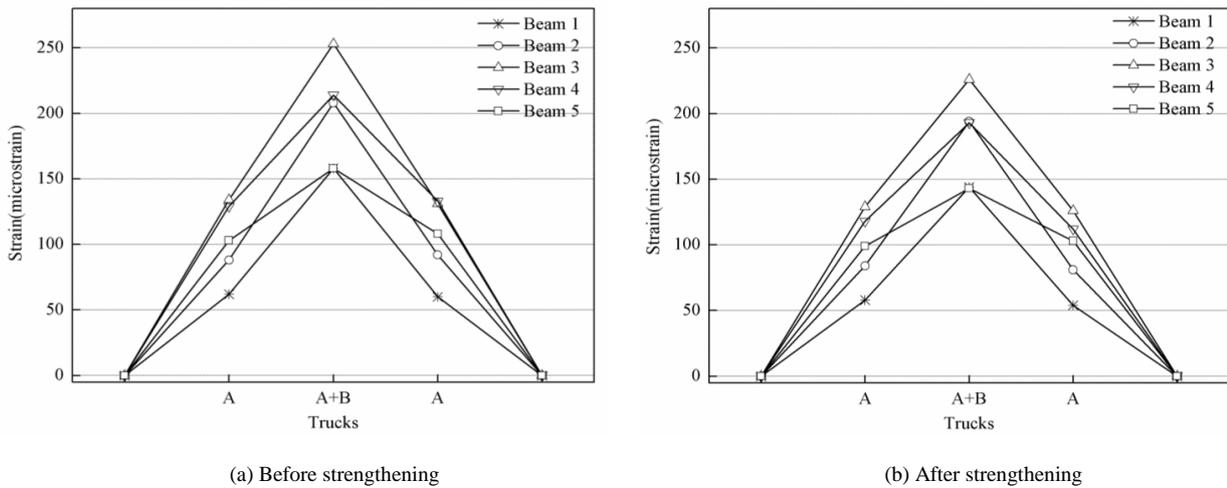
For condition 2, the concrete strains on the bottom concrete surface under live load before and after strengthening are shown in Fig. (13). The strain of beam 3 was the largest for the two trucks (Trucks A + B) because the two trucks were symmetrical to the centre of the bridge. The maximum strain of beam 3 was 253 microstrains before strengthening, and the strain became 226 microstrains after strengthening. Before strengthening, the strains of beam 4 and beam 5 were 214 and 158 microstrains, respectively, and after strengthening, the strains were 193 and 143 microstrains, respectively. In comparing the strains before and after strengthening, the concrete strain is reduced to some degree.

**Fig. (13).** Recorded concrete strains in condition 2. (a) Before strengthening. (b) After strengthening.

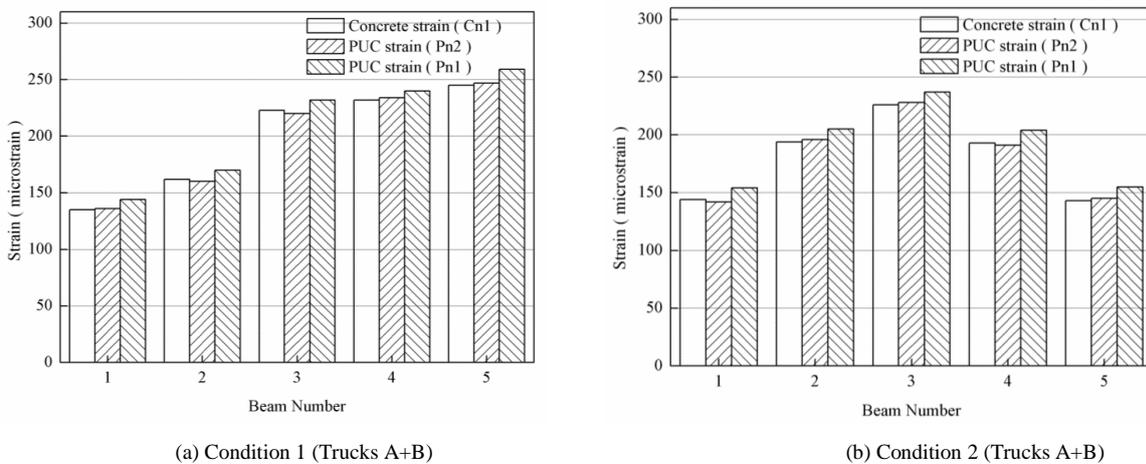
The recorded strain values of gages Cn1, Pn2 and Pn1 for the five beams in condition 1 and condition 2 are shown in Fig. (14). In comparing the recorded concrete strains (gage Cn1) and PUC strains (gage Pn2), the concrete strain values are close to the PUC strain values on the same horizontal height. Therefore, PUC strain compatibility is well at the live load. In comparing the PUC strains (gage Pn1) with those recorded on the concrete (gage Cn1), the PUC strains are higher than the concrete strains. Strain compatibility leads to the higher PUC strain than the concrete strain because the bottom PUC is physically located below the bottom concrete in the beam section.

**Fig. (14).** Concrete strains and PUC strains at different positions. (a) Condition 1 (Trucks A+B). (b) Condition 2 (Trucks A+B).

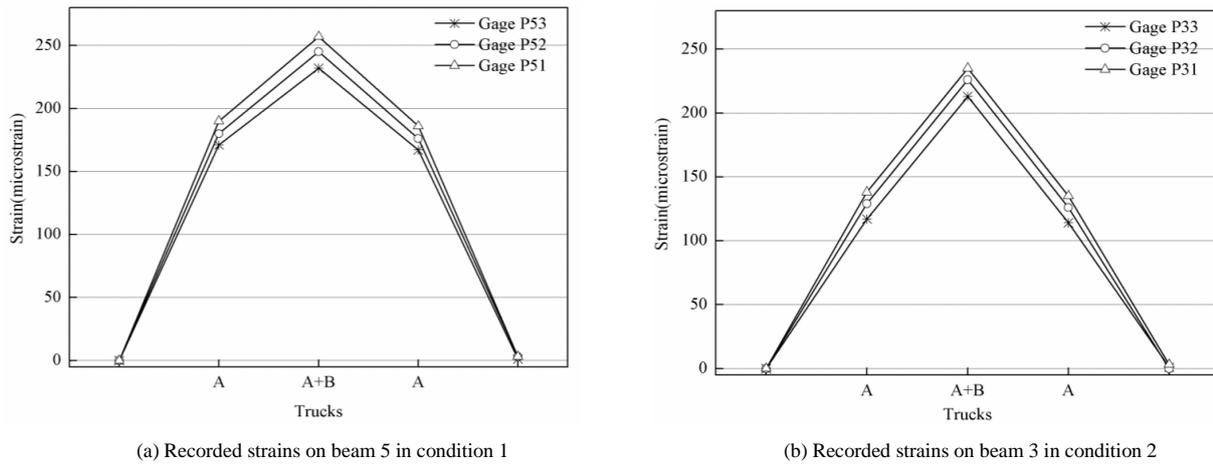
Measured PUC strains for different conditions and the various truck positions further confirmed consistency of the data and the effectiveness of the strengthening method in carrying load, as shown in Fig. (15). From this figure, for the given truck position, reading from gages P51, P52 and P53 of beam 5 in condition 1 clearly showed that strains were proportional to applied bending. Gages P31, P32 and P33 recorded flexural strains that were proportional to different truck positions in beam3 in condition 2.

**Fig. (15).** Recorded strains for gages mounted on PUC. **(a)** Recorded strains on Beam 5 in condition 1. **(b)** Recorded strains on beam 3 in condition 2.

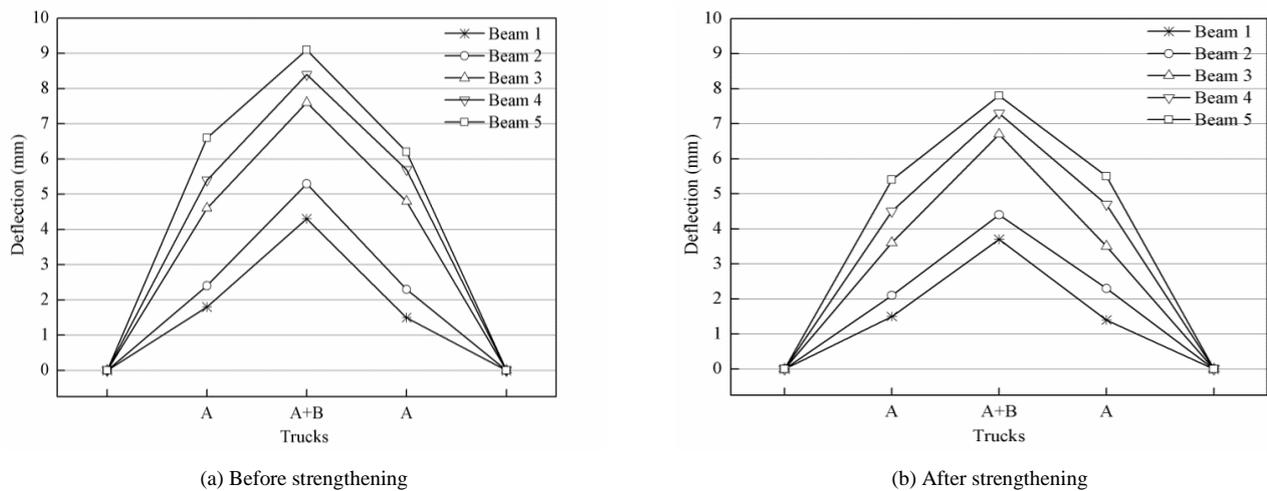
Dial indicators were installed on the bottom of the beams to measure the midspan deflection in the different conditions. The midspan deflection of all the beams before strengthening in condition1 is shown in Fig. (16a). The deflection of beam5 was the maximum under the partial truck load. The maximum deflection was 9.1mm for two trucks (Trucks A + B). Fig. (16b) shows the midspan deflection of all the beams after strengthening in condition 1. The deflection of beam5 was 7.8mm after strengthening. The maximum deflections of beam 4 and beam 3 were 8.4mm and 7.6mm before strengthening, respectively. After strengthening, the deflections were 7.3mm and 6.7mm for the two trucks (Trucks A + B). As expected, a certain decrease in deflection after the application of PUC reinforcement could be observed.

**Fig. (16).** Measured deflection of girders in condition 1. (a) Before strengthening. (b) After strengthening.

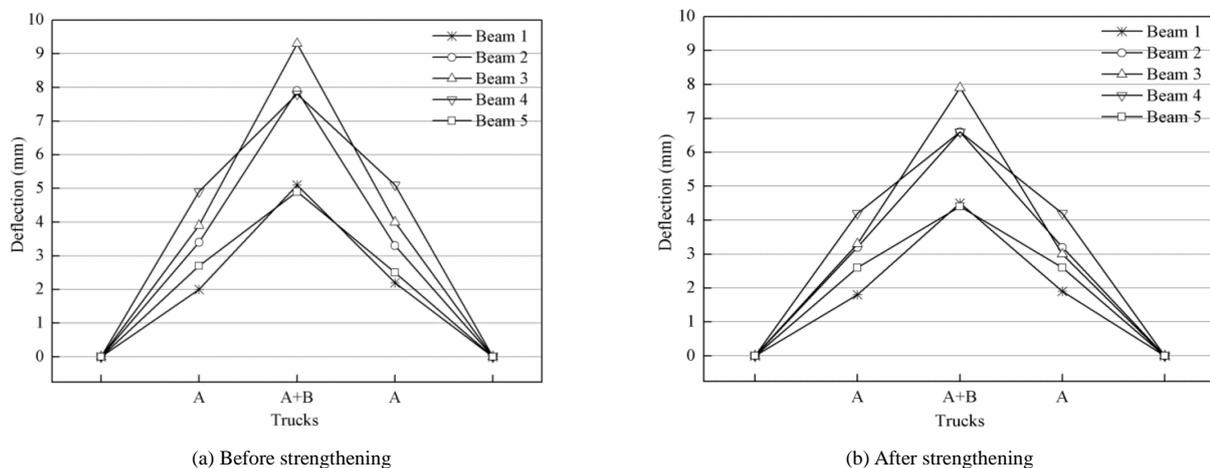
**Fig. (17).** Measured deflection of girders in condition 2. (a) Before strengthening. (b) After strengthening.

Fig. (17a and b) show the midspan deflection of all the beams before and after strengthening in condition 2, respectively. The deflections of beam 3 were 9.3 mm and 7.9 mm for the two trucks (Trucks A + B) before and after strengthening, respectively. The deflection decreased by about 1.4 mm after strengthening. Before strengthening, the deflections of beam 4 and beam 5 were 7.8 mm and 4.9 mm, respectively. After strengthening, the deflections of beam 4 and beam 5 were 6.6 mm and 4.4 mm, respectively.

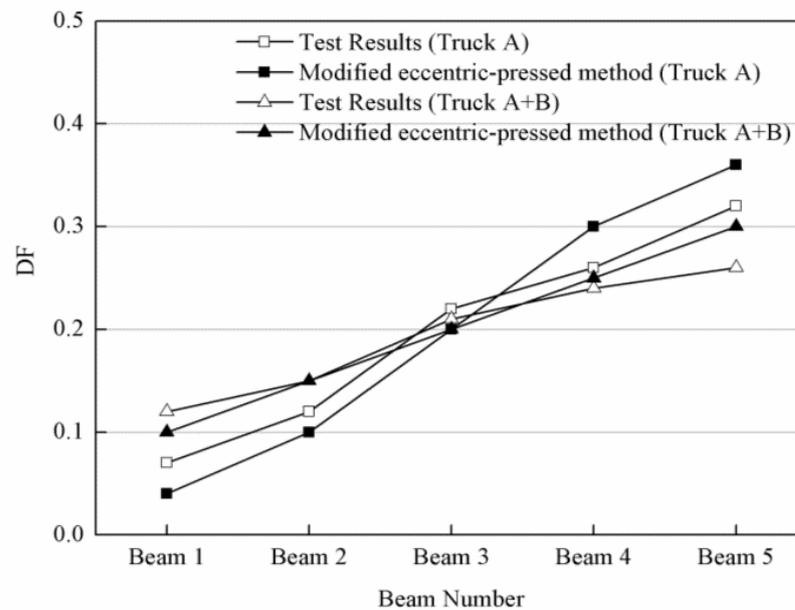
Fig. (18). Live -load DFs calculated from test results and modified eccentric- pressed method in condition 1.

Where  $\delta_i$  is the maximum static deflection in the  $i$ th girder, and  $i = 1\sim 5$ . The deflection measurements shown in Fig. (18) for Yun Liang Bridge in condition 1 were used to determine the live-load DFs according to Eq. 7. From the modified eccentric-pressed method [19], live-load DFs that can be compared with the measured DFs were provided as shown in Fig. (16). The exterior girder (beam 5) deflected by 6.6 mm for one truck (Truck A) in condition1. The total deflection of all of the girders was 20.4mm for a live-load DF of about 6.6/20.4 or 0.32. The live-load DF is 0.36 using the modified eccentric-pressed method. The live-load DFs depend on girder spacing, span, girder bending stiffness and girder torsional stiffness. The exterior girder (beam 5) deflected by 9.1 mm for the two trucks (Truck A + B) in condition 1. The total deflection of all of the girders was 34.7 mm for a live-load DF of about 9.1/34.7 or 0.26. The live-load DF is 0.30 using the modified eccentric-pressed method. Thus, the modified eccentric-pressed method is applicable for calculating the live-load DFs of T-beam bridges.
