# The Open Civil Engineering Journal

### Evaluation of Concrete Quality for Reinforced Concrete Frame Members Exposed to Natural Fires at Early Ages Using *in situ* Test Methods

#### Abstract:

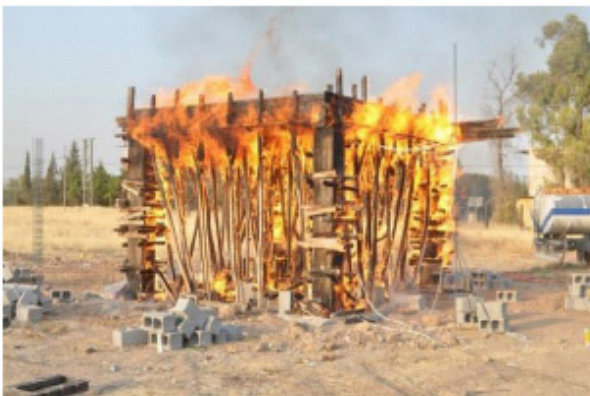
Fig. (2). Reinforced concrete frame exposed to fire.

The reinforced concrete frame specimens were cast in a wooden mold. The curing process started after 24 hrs and continued until the concrete age reached three days for FF3 and five days for FF5. Then the wooden mold of the reinforced concrete frame was fired, as shown in Fig. (2). The concrete temperature inside increased after the wooden mold was fired. The changing temperature inside the concrete was measured by inserting K-type thermocouples into the mold before casting and fixed at specified locations, as shown in Fig. (3).

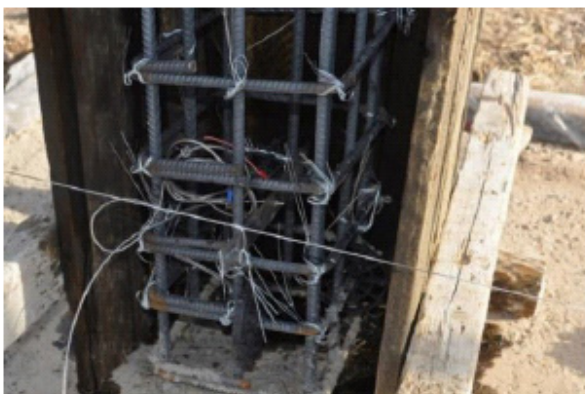
Fig. (3). Insertion of a thermocouple.

Twelve thermocouples were used in recording temperature inside the reinforced concrete frame. The column height divided into three equal parts, thus, two thermocouples were used at the bottom part, two thermocouples were used at the middle part, while the last two thermocouples were used at the top part of the column. The locations of each of the two thermocouples used in different parts of the column are as follows; the first thermocouple is fixed at a distance equal to the cover of concrete while the second thermocouple is fixed at the center of the column section. Similarly, three thermocouples were used at the center of beam span and distributed as

follows: the first and third were inserted at a distance equal to concrete cover from inside and outside of beam cross-section while the second was inserted at the center of beam section. Finally, the two thermocouples were used in the center of the slab and at different heights, one at the top and the second at the bottom of the slab.

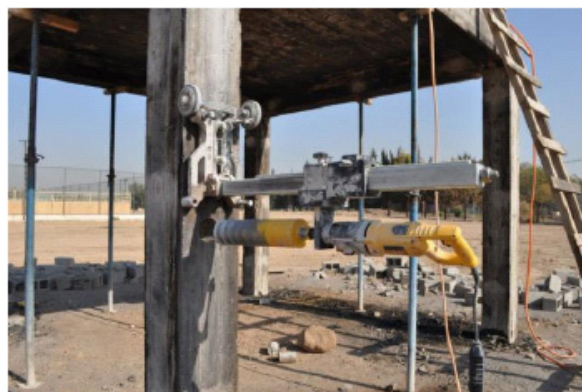
Fig. (6). Core location in reinforced concrete frame.

The drilling samples from reinforced concrete frames were collected from three different elements. The three core samples were collected from each of the columns, beams, and slab, as shown in Fig. (6).

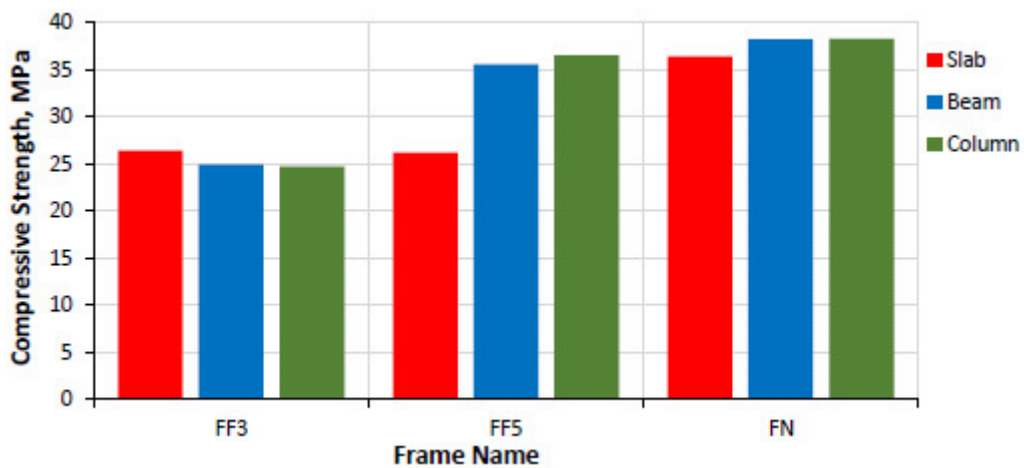
Fig. (8). The compressive strength of concrete elements according to the core test.

Fig. (8) presents a bar graph that shows the compressive strength of the core samples taken from the slab, beam, and column elements in different frame structures. Generally, the compressive strength of the core samples collected from frames exposed to the fire was lower than that of the frames that were not exposed to the fire. The reduction in compressive strength of core samples in the slab element showed that FF3 and FF5 have the same value, which was 28% in comparison to the FN which was not exposed to the fire. After the beams were exposed to fires, the compressive strength values of the core samples in FF3 were reduced by 35%, whereas the compressive strength value of the core sample was reduced by 7% in FF5 when compared to FN. The compressive strength of the core samples in the column elements was reduced by 35% and 5% for FF3 and FF5, respectively, when exposed to fires. The previous comparisons in compressive strength of core samples of frames in different elements show that the compressive strength of the core samples is more affected by the fire at an earlier age than older.

Taking core specimens from concrete suspected of being damaged by fire is common [38]. In each reinforced concrete frame, FF3 and FF5 core samples were taken after being exposed to fire. By contrast, in frame FN, core samples were taken without exposing the structure to fire. The core samples were prepared by cutting the end parts and then creating cupping for them. All necessary dimensions and information were then recorded. To study the effect of fire on concrete at an early age, all the core samples were tested to check their compressive strength. The results are shown in Table 8 and Fig. (8).
