# Corrosion Monitoring Using Embedded Piezoelectric Sensors

**Abstract:** In this research, a new type of corrosion monitoring technique for reinforce concrete was developed. The technique used piezoelectric sensors to detect the ultrasonic signals during corrosion. The mechanism of the method was presented. Experiment was carried out to monitor the corrosion process using piezoelectric sensors. The corrosion was also monitored using stain gauge for comparison.

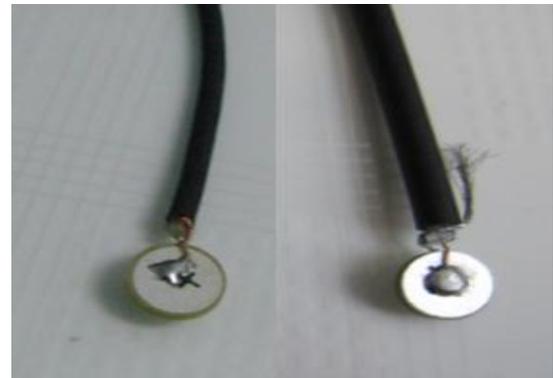
(a) Piezoelectric element

Fig. (1). Piezoelectric ceramic and the corrosion sensor.

The piezoelectric sensor included two piezoelectric ceramic elements which were used for generating and receiving ultrasonic waves and one steel bar was used as wave guider. The diameter of the piezoelectric ceramic element was 10 mm and the thick was 1 mm. Coaxial cable

was connected to the opposite electrodes of the piezoelectric ceramic element. Then, the piezoelectric ceramic was enclosed using epoxy. At last, the piezoelectric element was bonded onto the opposite surfaces of a steel bar of 100 mm. The sensor is shown in Fig. (1).

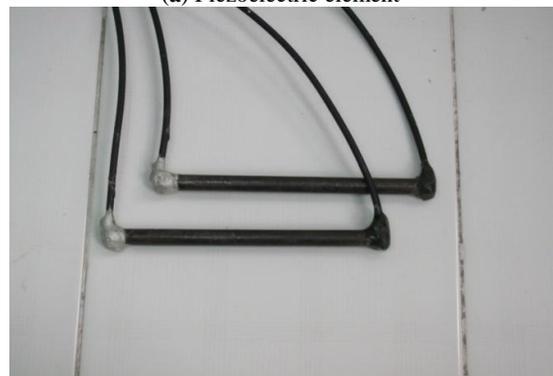
(b) Corrosion sensor

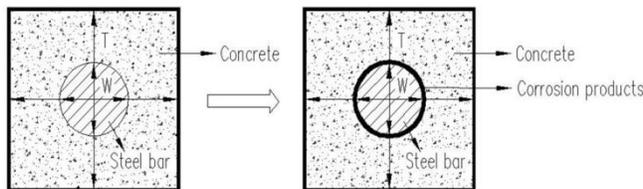
**Fig. (2).** Ultrasonic waves propagating in steel bar and concrete.

(W: wave propagating in steel bar; T: wave transmitted into concrete)

As is known that the corrosion process is the accumulation of different types of oxidation products. The corroded part of a steel bar may induce increase of the volume because the corrosion products have different material properties. The steel bar was designed to guide the ultrasonic wave. When the sensor was embedded into concrete, part of the wave energy would transmit to the concrete. When the corrosion products were accumulated, less wave energy would emit to the concrete. Thus, during corrosion the wave amplitude would change. The working principle is shown in Fig. (2).

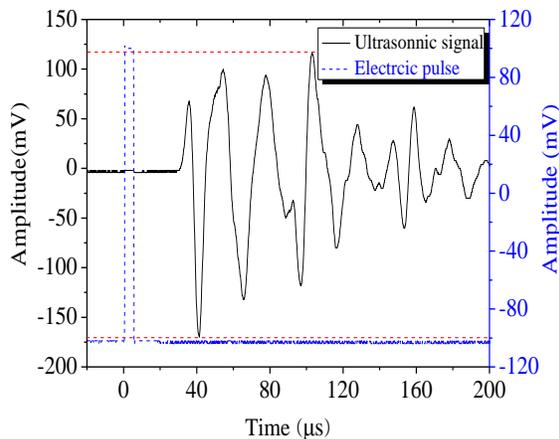
**Fig. (3).** Ultrasonic wave received before the sensor was embedded into concrete.

Before the corrosion sensor was embedded in concrete, the properties of the sensor were examined. One piezoelectric element was stimulated by an electric pulse from a signal generator (Agilent 33120A) and the other piezoelectric element was used to receive the ultrasonic wave, which was recorded by an oscilloscope (Tektronix TPS2024). The input electric pulse was a step function of  $\pm 10V$ . The input electric pulse and the received wave are shown in Fig. (3). The sensor was then cast into a concrete beam with a cover thickness of 10 mm. After one week curing, the operation was repeated. The received wave is shown in Fig. (4). After the sensor was embedded into concrete the wave amplitude decreased obviously. It could be seen that the sensor could response to the change of its surrounding state. Next, the sensor would be used to monitor the corrosion process.

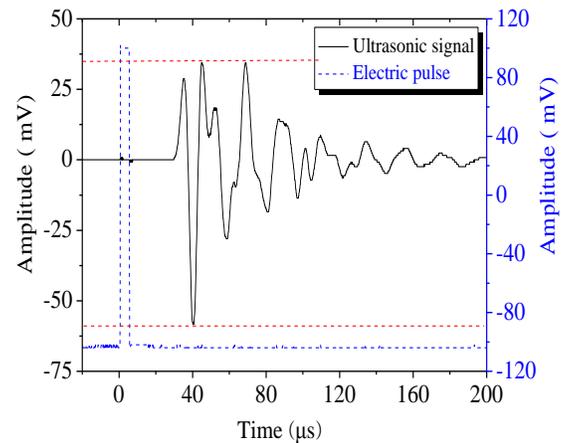
**Fig. (4).** Ultrasonic wave received after the sensor was embedded into concrete.

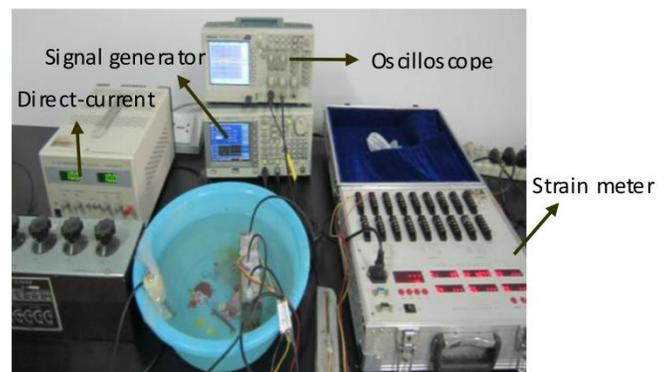
**Fig. (5).** Test instruments used in corrosion monitoring.

In order to accelerate corrosion process, the concrete specimen with embedded sensor was placed in 3% NaCl solution and the corrosion circuit was connected using the direct-current power. The embedded reinforcement bar in the specimen was connected to the anode of the direct-current power and the copper rod was connected to the cathode of the direct-current power [16]. Both ends of steel bar were connected with signal generator and oscilloscope. Strain gauge was also bonded onto the surface of the concrete beam to measure the strain of the specimen. The instruments in the acceleration test are shown in Fig. (5). The potential used in the acceleration test was 2 volts. The ultrasonic wave signals were measured per hour. Measurement was stopped until the cracks appeared on the surface of concrete specimen.

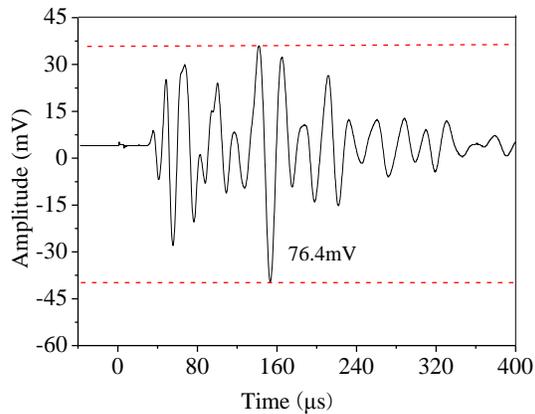
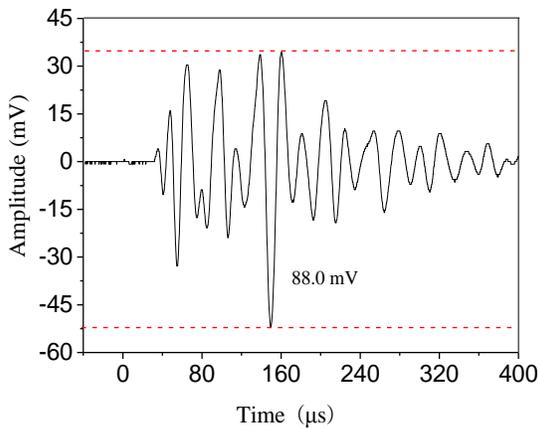
(a) Wave received at 10 h

(b) Wave received at 60 h

Fig. (6). Ultrasonic wave received in the test.

The waves recorded at 10 h and 60 h are shown in Fig. (6). During corrosion the amplitude of the wave increased. The reason is interpreted in the above. The corrosion product layer decreased the transmitted wave energy. Thus, the amplitude increased.

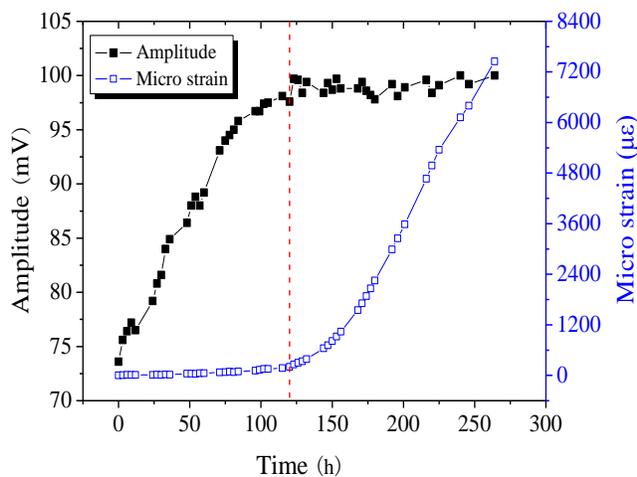
Fig. (7). Increase of amplitude and micro strain versus time.

The relation of time, wave amplitude and strain is shown in Fig. (7). During the early stage of the corrosion, the wave amplitude and the strain both increased linearly.

At about 120 h, the amplitude stopped increasing and the strain increasing rate became very large. We know that when the strain increased very quickly, it means that small cracks around the steel bar were induced due to the expansion the

corrosion product. The cracks changed the way the wave propagation from steel bar to concrete.

Thus, the amplitude of the wave could detect the initiation of the corrosion and the cracking of the concrete. It should be noted that the experiments had very good repeatability.
