# The Open Transportation Journal

# Developing the New Barrier Condition Index (BCI) to Unify the Barrier Assessments - A Case Study in Wind River Indian Reservation, Wyoming

Amirarsalan Mehrara Molan\* and Khaled Ksaibati

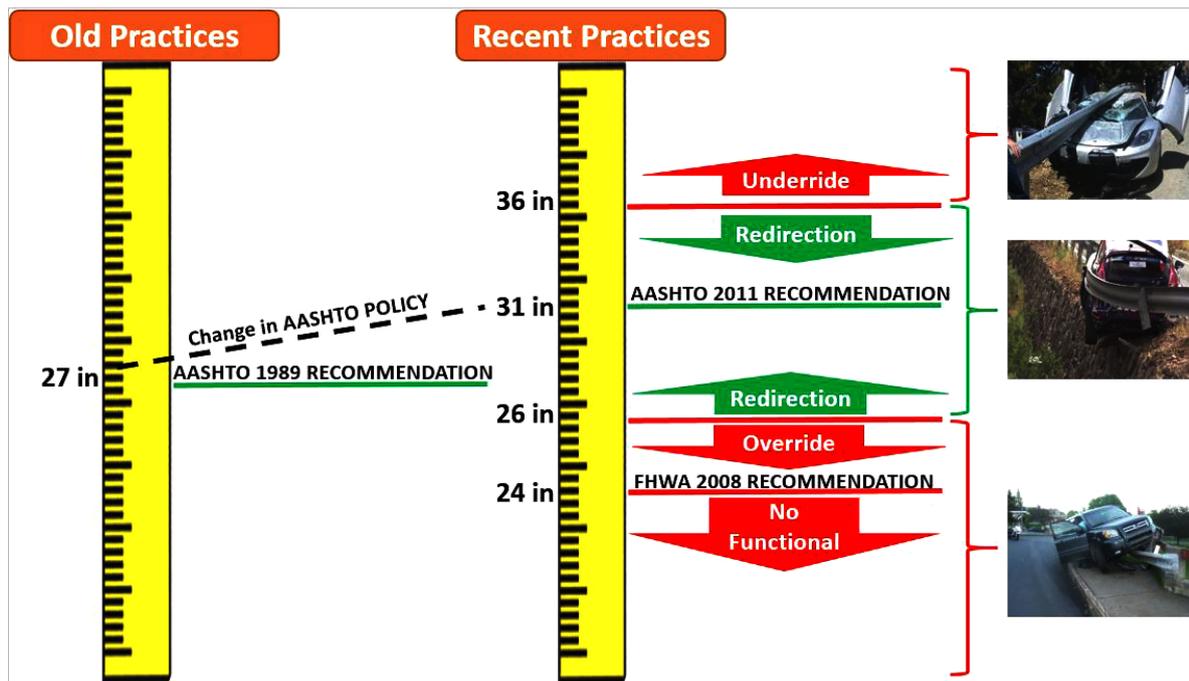
Fig. (1). A summary of the effect of W-Beam guardrail height on crashes.

The low-height barriers raise the propensity of vehicle rollover and override, while very tall-barriers are also promoting the vehicle underride [9]. According to Wiebelhaus *et al.* [5], the low-height of 60 cm (24 inches), and 66 cm (26 inches) will increase the potential of vehicle override in W-Beam guardrails. However, the 70 (the old recommendation of RDG in AASHTO 1989), 74, and 76 cm height will lead to a redirection of the vehicle. This override can be even more dangerous for the vehicles with high Center of Gravity (CG) in low-height barriers. Based on FHWA's W-Beam Guardrail repair [10], the guardrails with a lower height of 60 cm (24 inches) were categorized as "no longer reasonably functional." On the other hand, a height more than 91 cm (36 inches) will increase the potential of an underride crashes in guardrails [9]. Fig. (1) shows a summary of the discussion regarding the effect of height on safety.

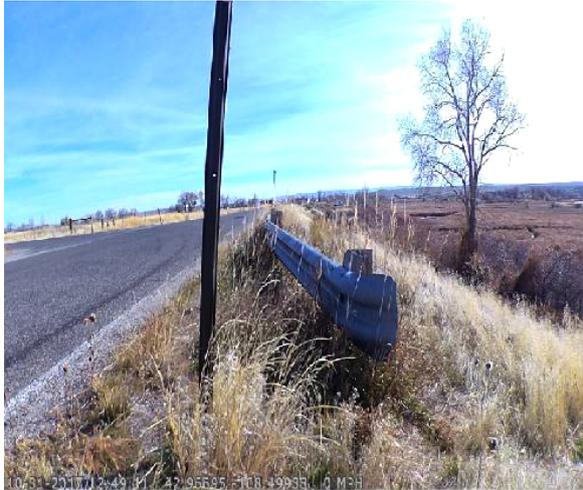
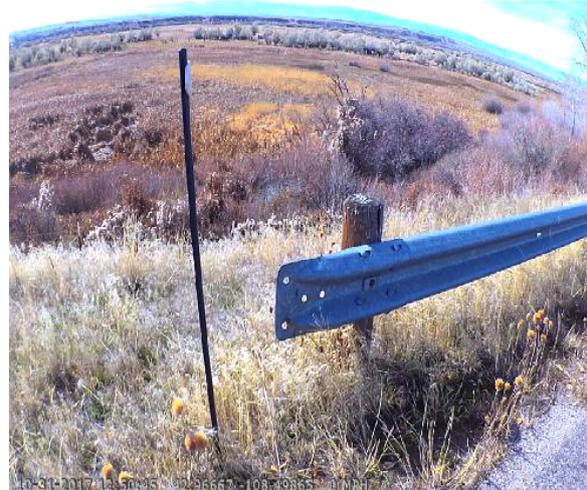
**Fig. (5).** Condition of end-treatments at site No. 1.

One of the important items in any barrier evaluation is the end-treatment. Fig. (5) shows the current end-treatments at site no. 1. As it is shown in Fig. (5), one of the end-treatment seems to be a “trailing end W-Beam guardrail anchorage” type while a part of the end-post is missed. The existing end-post can apply a serious damage to vehicles involved in a crash. In other words, it would perform the same as a sharp blade in the collisions. The first end-treatment was also missing the end terminal portion. As another concern regarding the existing end-treatments, the bridge transitions were not designed well. Bridge transitions are very important because they are mostly joined of two different type of barriers (usually a rigid barrier on the bridge and a guardrail system as the end-treatments) with different stiffness, strengths, and geometric features. In such cases, it is required to use adequate blackouts and additional posts or rail elements to provide a proper stiffness transition to remove the potential vehicles snag or pocketing near the bridge end [5].

**a. End-treatment No. 1**

**b. End-treatment No. 2**

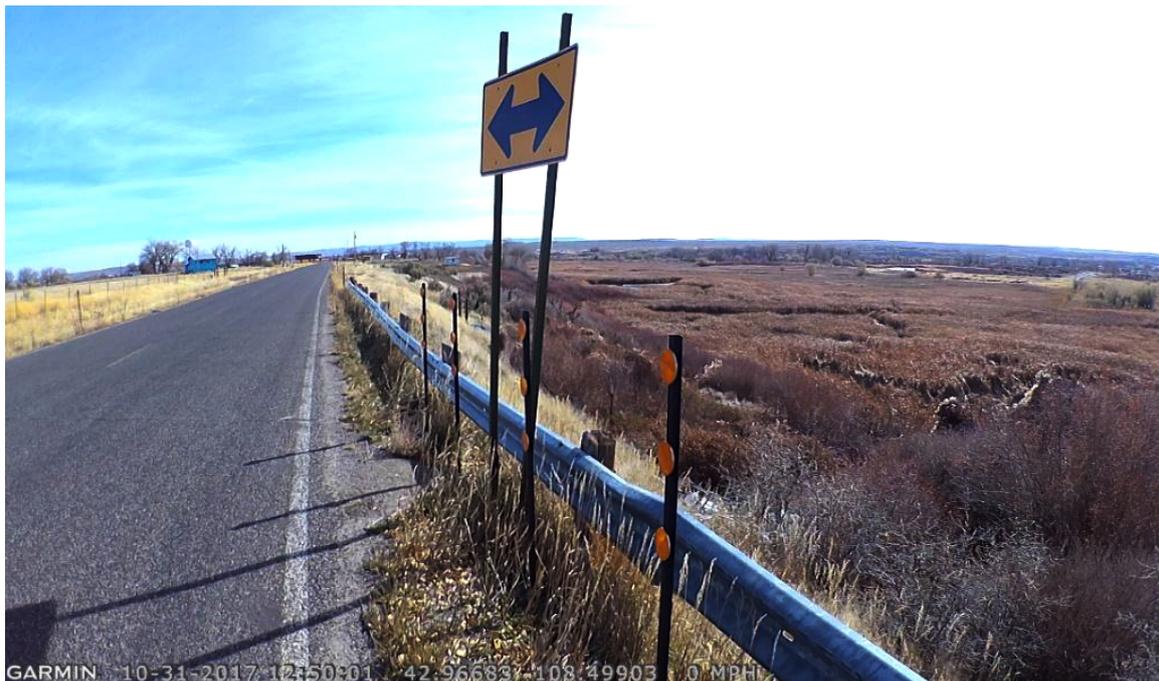
**Fig. (6).** Wrong placement of traffic signs at site No. 1.

As shown in Fig. (6), the traffic signs were not placed behind the guardrail in one of the sites, and this could impact the performance of the barrier in crashes.

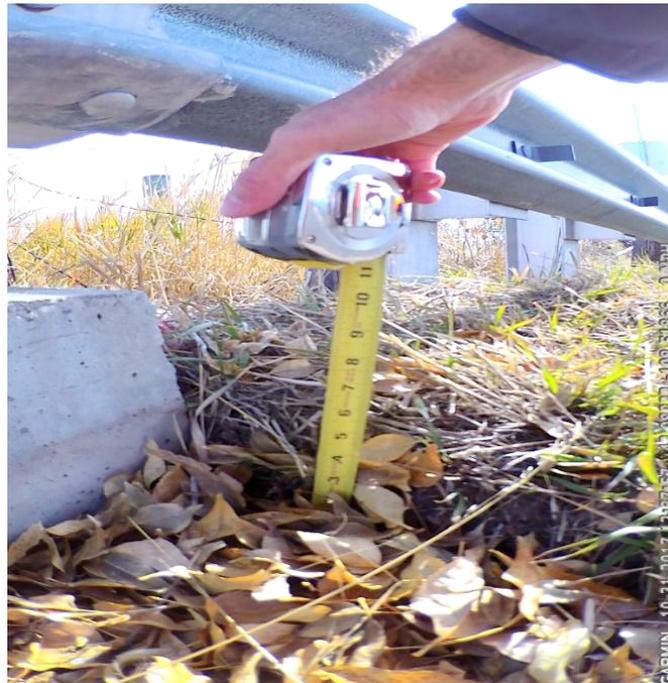
Fig. (7). The elevation of accumulated dirt at the bottom of posts.

As a side note, approximately, many sections had around 13 cm (5 inches) of accumulated dirt at the bottom of the end-treatments' posts. For this reason, despite the correct installation of the 78 cm (31-inch) height, the existing height of guardrails was measured as 66 cm (26 inches) which make a high-severity damage based on Table 1. This point is shown clearly in Fig. (7).
