Evaluation of Hydraulic Characteristics of the Normal Fault Based on Key Data

Abstract: Based on the data of geological drill holes, roadway drifting, transient electromagnetic exploration, mine water inrushes, hydro-geochemistry and water levels on each side of the Haotang Normal Fault, this paper studies the water-bearing capacity and water conductivity of the fault in the Pingdingshan Tian'an Mining Company Limited No. 7 Coal Mine. The results indicate that the Haotang Fault is subject to compressive or shear-compressive stresses. The water-bearing capacity and water conductivity of the fault is poor. The water content of the Cambrian limestone in footwall is higher than that in hanging wall, and the mining threat of 1_5 coal seam in the south district (footwall) is greater than that in the north district (hanging wall).

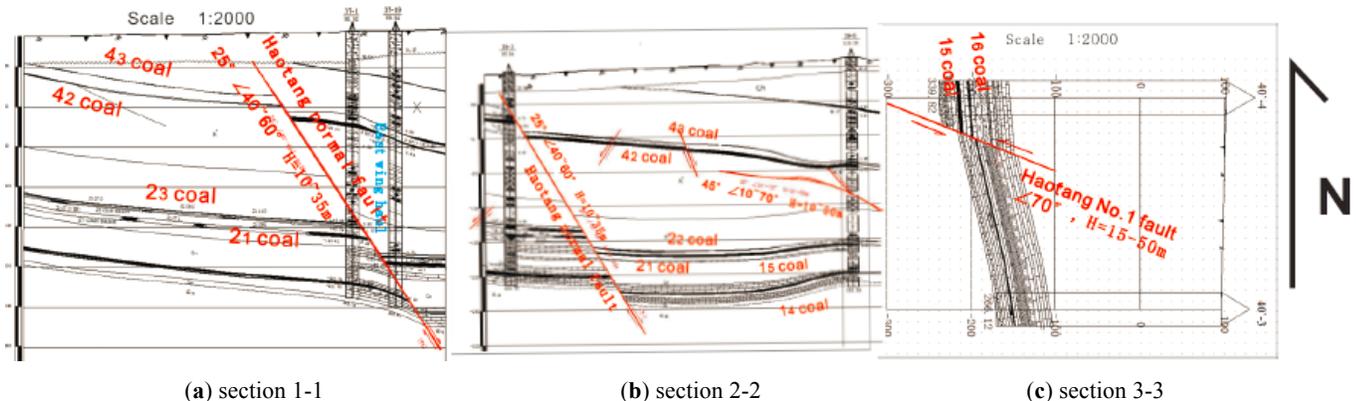
Fig. (3). Cross-sections through the Haotang fault. Source: [15].

Fig. (3) shows three typical north-south cross-sections of the coal measures and aquifer, with the locations of the Haotang Fault and other minor faults. In section 1-1, the CL in the north and south districts are seen to be directly linked. Section 2-2 shows that the CL in the south district is directly connected to the 1₅ coal. Section 3-3 illustrated the connection between CL and the L₆₊₇ limestone in north district. The distinct strata connections at the different locations illustrate the complex influence of the fault on the various strata.

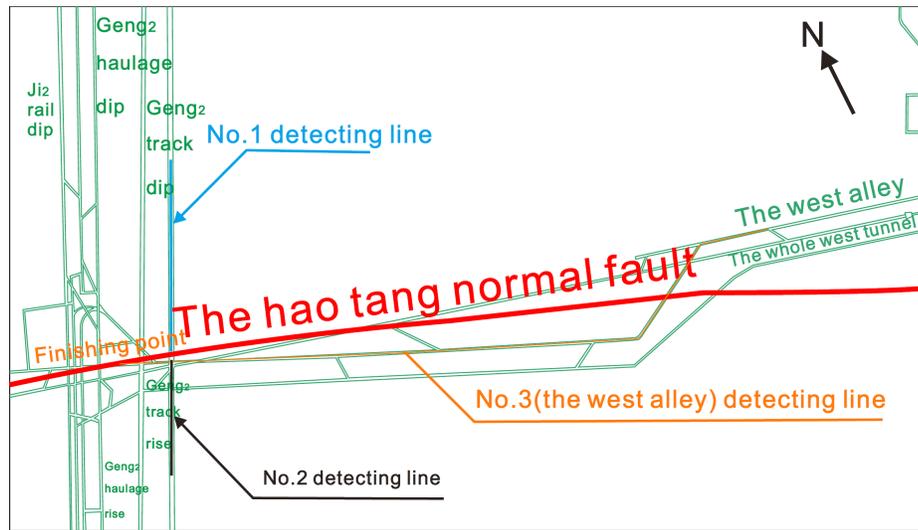
Fig. (4). Map of the TEM detecting line position. Source: [15].

To survey the water yield properties of the fault, we carried out floor TEM on lines parallel to the fault along the western roadway. The No. 3 detecting line was 780 m long, beginning from the north of the Haotang Fault, passing through the fault to the southern side, then turning north westward and finally re-entering the fault zone (Fig. 4).

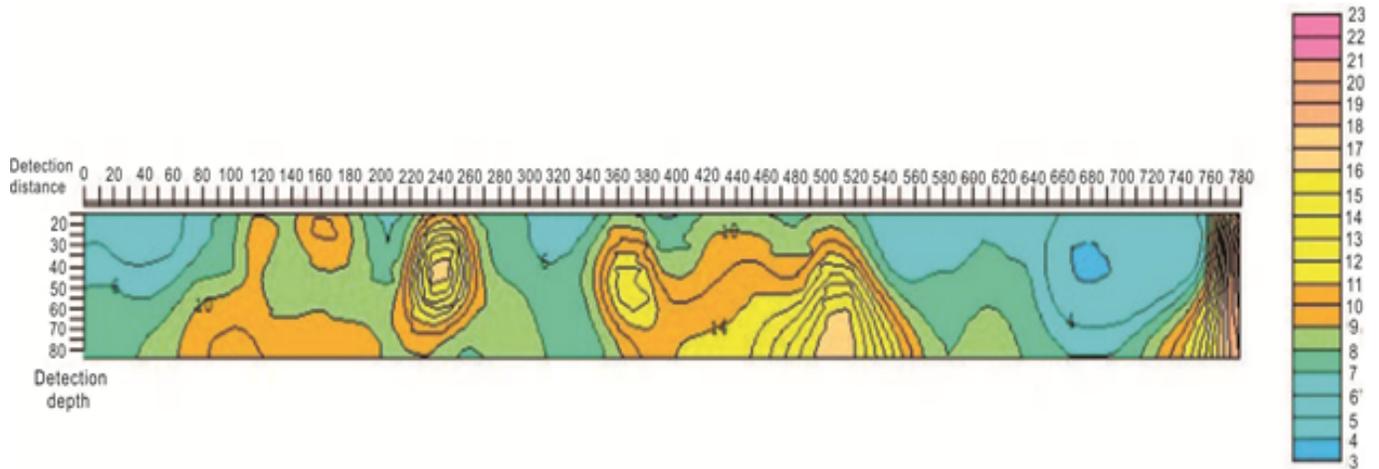
Fig. (5). Diagram of the floor TEM apparent resistivity section of the No. 3 line. Source: [15].

Fig. (5) (see the next page) is a cross-sectional diagram of the floor TEM results on detecting line No. 3. Clearly, the apparent resistivity was higher at 220-250 m, where the detecting line cut across the Haotang Fault and was highest at the finishing point (760-780 m) in the fault zone. Normally, higher apparent resistivity indicates poorly developed limestone karst fissures and associated low water yield. This is a further evidence that the water yield of the Haotang Fault is weak.

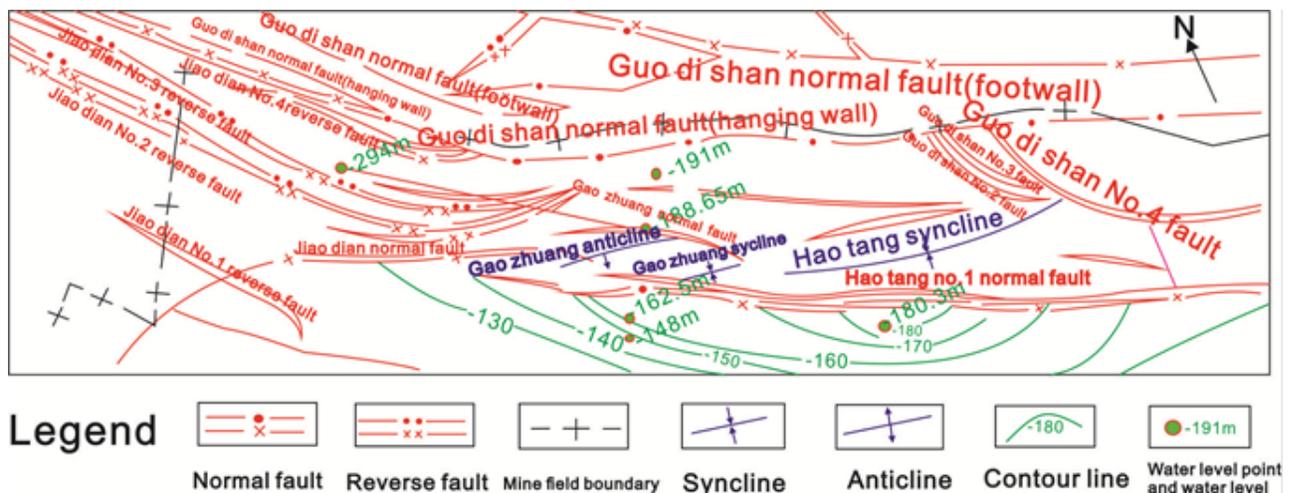
Fig. (6). Isoline map of water table levels in the CL aquifer. Source: [15].

The water level in the CL was measured in September 2012. The observed values are shown in Fig. (6) as CL water table isolines on the southern side of the Haotang fault. It can

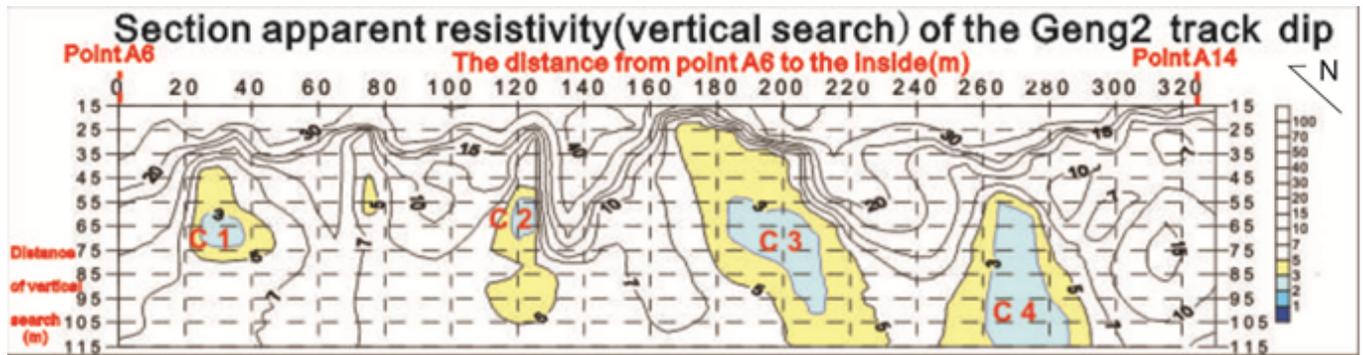
Fig. (7). Apparent resistivity section diagram for line 1. Source: [16].

parent resistivity values were located at the Geng₂ track dip roadway of 185-210 m and 260-285 m, and at depths of 55-105 m and 55-115 m. The rocks near the low resistivity zones are fractured karst or high water-content zones. None of the anomalies in the low-resistivity zone gave apparent resistivity readings less than 2 Ω-m, signifying the relatively small water-bearing capacity of the overall CL aquifer on the northern side of the Haotang fault.

No apparent resistivity readings less than 2 Ω -m were observed on line 1, and the water-bearing anomalies covered a smaller area than those on line 2. These facts illustrate that the aquifer contains more water in the south of the fault than in the north of the fault. They also indirectly confirm that the CL aquifer groundwater contact isn't close to both sides of the fault.

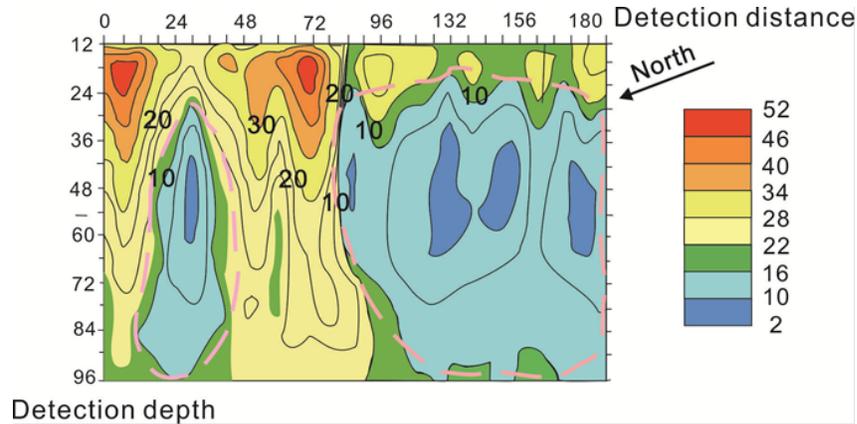
Fig. (8). Apparent resistivity section chart for line 2. Source: [16].

At the time of the readings on line 2, interference was small and the background apparent resistivity was as high as 54 Ω-m. Values below 10 Ω-m occurred only in relatively anomalous low-resistivity zones. Fig. (8) is a cross-sectional chart of the floor TEM results, showing the locations of the lower apparent resistivity values at the Geng₂ track rise roadway of 18-40 m and 84-180 m, and at depths of 30-90 m and 24-90 m. Zones of apparent resistivity less than 2 Ω-m in the south of the Haotang fault are corresponded to the presence of well-developed karst fissuring in the CL, from which we inferred that the anomalous low-resistivity zones indicated large volumes of water stored in the strata. Subsequently, inrushes of water from the floor did in fact occur when these zones were breached by excavation for roadways development, which confirmed the validity of our inference.
