The Open Dentistry Journal

Effect of Contamination, Damage and Barriers on the Light Output of Light-Curing Units

Abdulhaq A. Suliman^{1*}, Ahmad A. Abdo¹ and Hussein A. Elmasmari¹

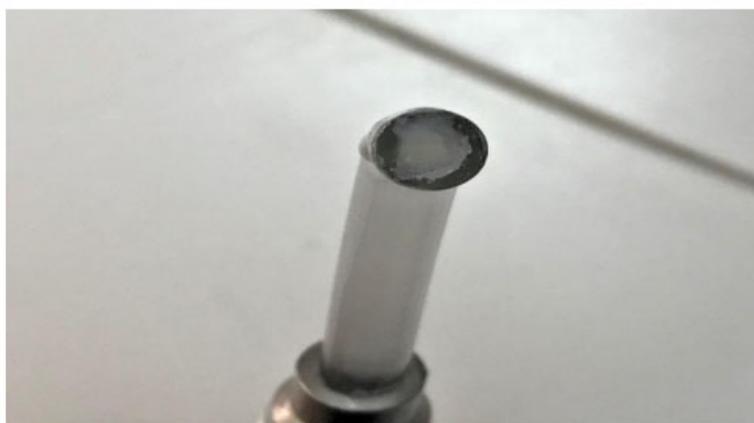
Fig. (1). A layer of composite residue covering most of the tip of one LCU as received before cleaning.

Group 1 showed an average energy of 16.99 J/cm². Group 2 had the lowest energy values with an average of 15.78 J/cm². Group 3 achieved the highest energy values an average of 18.53 J/cm². Group 4 showed an average of 17.18 J/cm². (Table 2) shows the mean energy, standard deviation, minimum and maximum energy for each group. The statistical analysis using Kruskal-Wallis H test showed that cleaning the tip of the LCU resulted in a significant effect (*P*<0.05), increasing the amount of energy delivered by all the LCUs. There was an average of 8.2% improvement in energy when comparing group 1 to group 3 and when comparing group 2 to group 4. Fig. (1) shows a contaminated LCU’s tip, a layer of

composite residue covers most of the tip, reducing the amount of light energy delivered by the LCU to the restoration. The analysis also showed that using a barrier can cause a slightly significant reduction the energy values (*P*<0.05). There was an average of 1.27 J/cm² (7.28%) reduction in energy when comparing the barrier groups (2 and 4) to the no barrier groups (1 and 3).

When the LCUs were collected, it was noticed that most of the units had debris and contamination present on the light guide tips ranging from a layer of adhesive to big chunks of composites. It was clear from the reports that cleaning the tips of the LCUs had significant effect on the light output and amount of energy delivered by these LCUs. However, since the increase in energy was dependent on the amount of tip contamination and debris that was removed, which was not consistent as some LCUs were well maintained and had almost

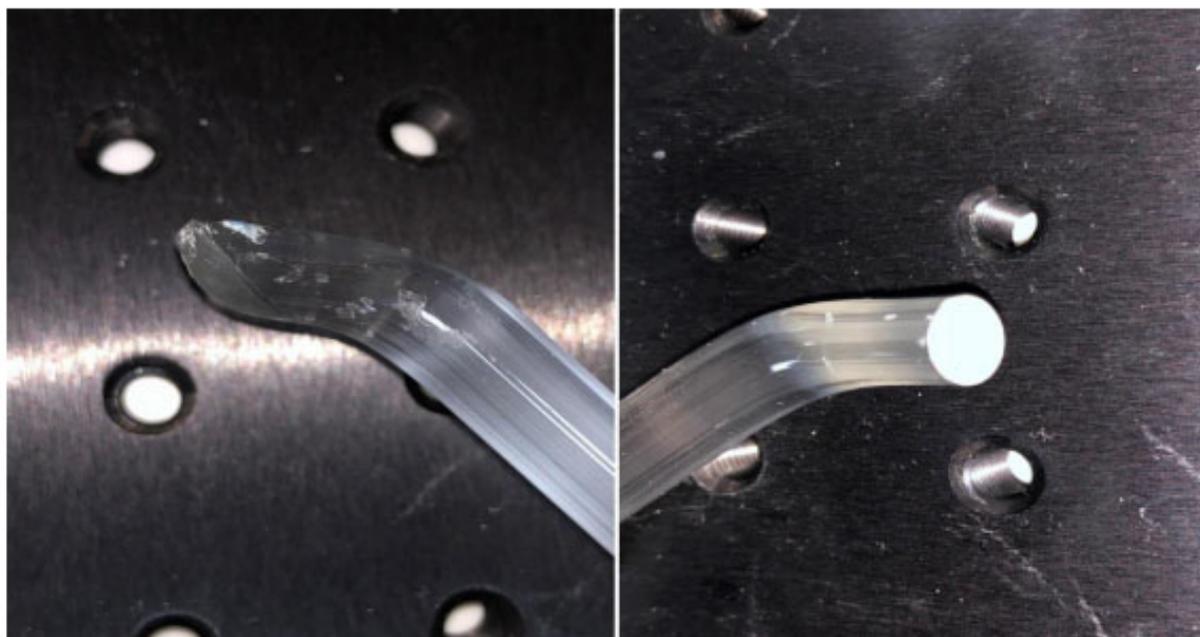
Fig. (2). Shows a damaged tip for (Acteon mini LED) versus a new tip.

(Table 4) shows the effect of changing the damaged tip to a new one on the irradiance and energy delivered by the LCUs. The four damaged LCUs improved by 9.46%, 30.77%, 38.71% and 73.46% after changing their tips. The analysis showed that changing the damaged tip with a new one had a significant effect ($P < 0.05$). Fig. (2) shows the damaged tip and the new tip that was used to replace it for Acteon mini LED. This caused a 73.46% improvement in the irradiance and light energy delivered.

After replacing the damaged tip with a new one the energy increased for all 4 LCUs. However, the energy improvement ranged from 9.46% to 73.46%. Meaning that the type and extent of tip damage will determine how much it can affect the LCU's light output, but no doubt a damaged tip can cause a significant drop in energy delivered by the LCU, because light will be scattered instead of being directed directly to the restoration. Therefore, dentists must not use LCUs with damaged tip and should replace it with a new tip if possible. A study performed in 2011 has showed how damage to the LCU's tip can significantly reduce its light output [14].
